Luas Finglas

Appendix A11.2: Generic Qualitative Risk Assessment Report

Luas Finglas Rail Project

Generic Quantitative Risk Assessment

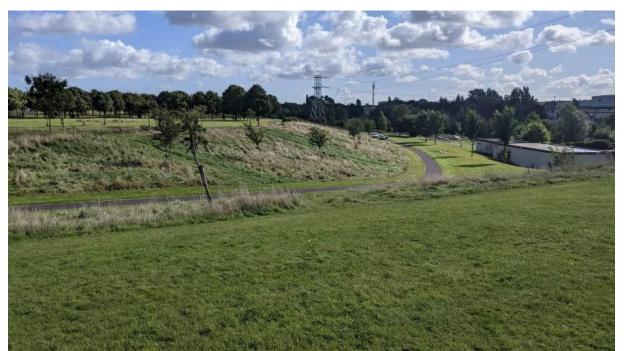
Figure 3-2 Overview of Tolka Valley Park, facing east

A GDG engineer attended site during the excavation of trial pits LF-TP-2010 and LF-TP-2011 in Tolka Valley Park. Photographs from this visit are included in Figure 3-2 to Figure 3-5, and the locations are highlighted in blue in Figure 3-1.

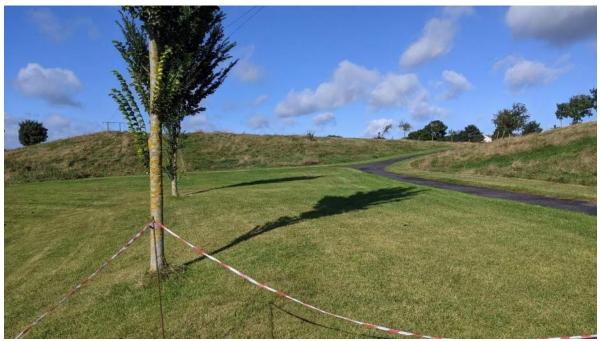
Figure 3-3 Overview of Tolka Valley Park, facing west from LF-TP 2011

At LF-TP-2011, plastic waste was noted throughout the soils, with soil mixed with plastic bags and metal rebar. The material became more cohesive with depth, and a mudstone boulder or bedrock was identified at 3.2m bgl. No odours or evidence of obvious contamination was noted.

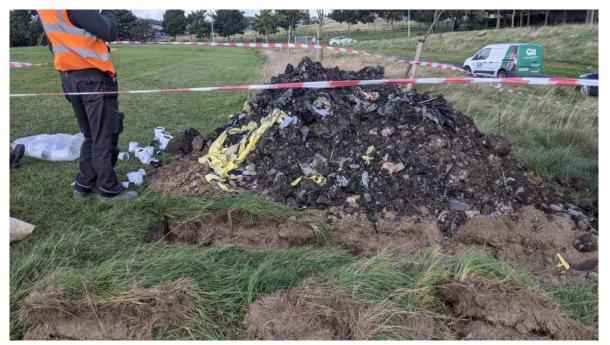
Figure 3-4 Landfill Waste Excavated from LF-TP-2010

The engineer noted that at LF-TP-2010, a reworked clay with occasional brick fragments 2.6m thick (i.e., a cap) overlying Made Ground between 2.6m and the termination depth of 4.35m bgl. This Made Ground showed characteristics of landfill waste, with lots of plastic, shoes, magazines, and other domestic waste. A bad odour was noted, consistent with decomposing waste. The depth of the landfill material was not confirmed, as was restricted by the depth that the excavator could reach.

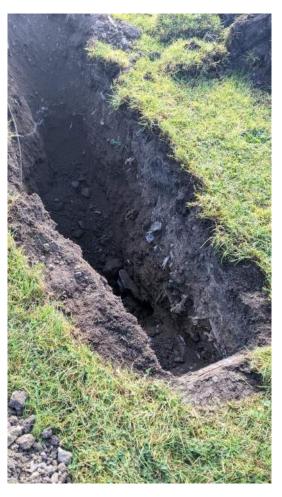
Figure 3-5 LF-TP-2011 Excavation. Visible sandy cap over landfill material
